**DETERMINATION OF THE EXTENT OF ION THRUSTER EFFLUX DEPOSITION ON
SPACECRAFT SURFACES FROM THE SERT II FLIGHT THERMAL DATA**

by N. John Stevens
Lewis Research Center
Cleveland, Ohio 44135

TECHNICAL PAPER to be presented at
Eleventh Electric Propulsion Conference
sponsored by the American Institute of Aeronautics and
Astronautics
New Orleans, Louisiana, March 19-21, 1975

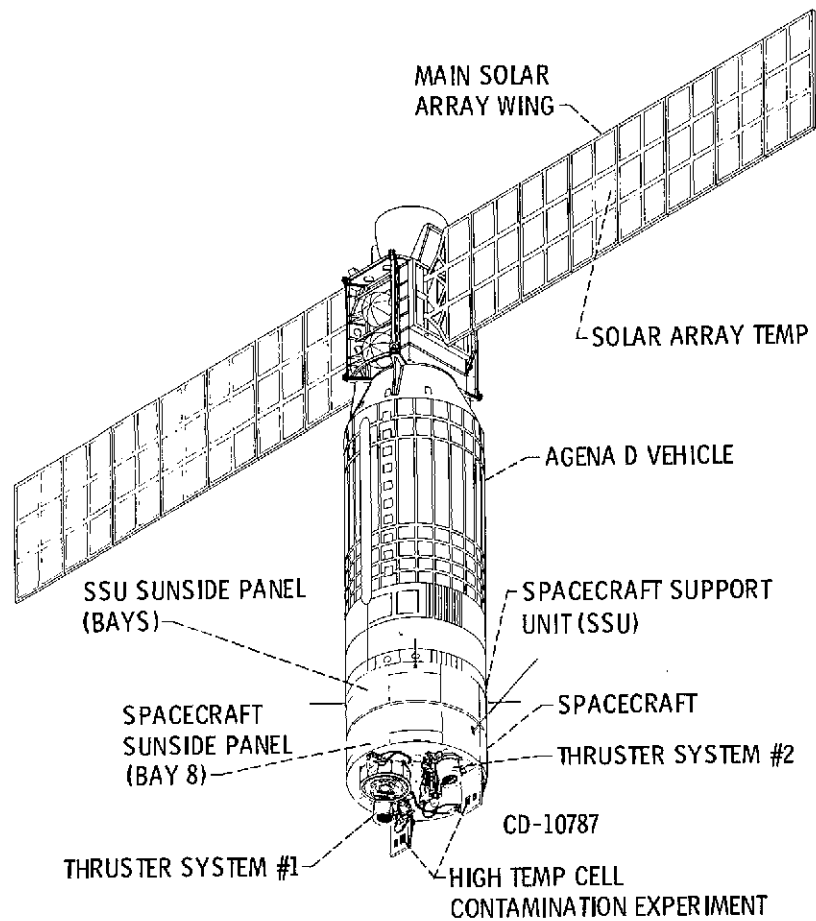
Figure 1. - Component & Temperature Sensor Locations Sert II Satellite.

In its orbiting configuration the SERT II satellite consisted of the Agena D booster; a spacecraft support unit (SSU) which housed the command system, telemetry, and control moment gyros (CMG's); and a spacecraft section which housed the two ion thruster systems and associated experiments (see fig. 1). The satellite power was provided by two solar array wings capable of generating about 1.5 kilowatts of power and located at the Agena end of the satellite. The ion thrusters were the one kilowatt, mercury bombardment thruster described in the literature.⁽¹¹⁾

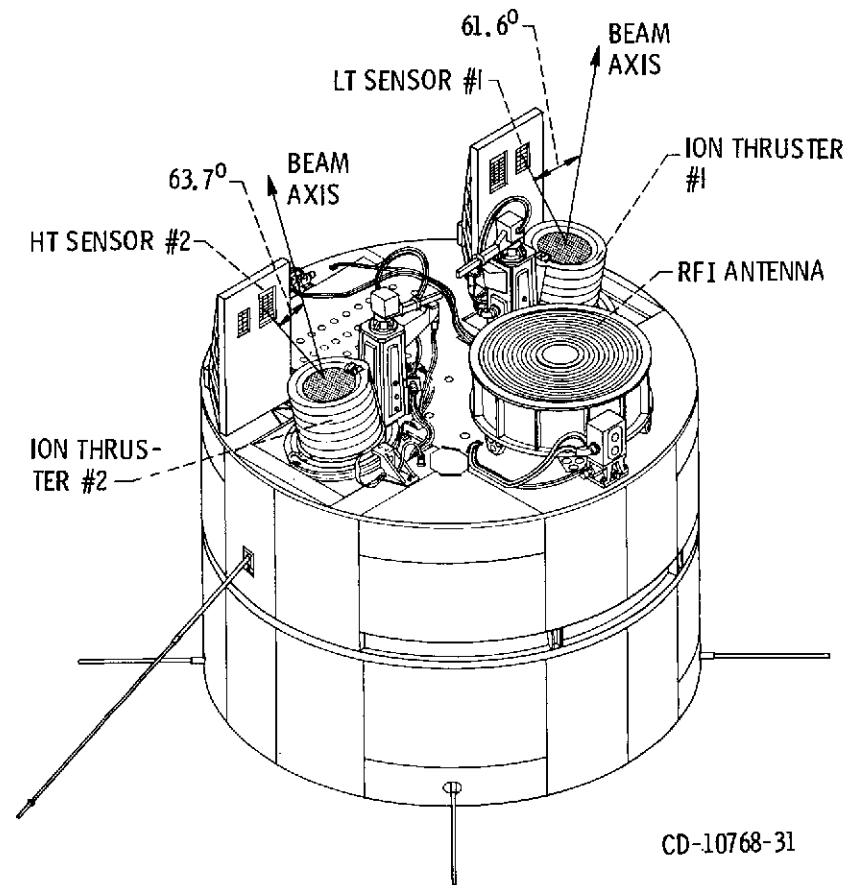
Figure 2. - SERT II spacecraft showing contamination sensor locations.

A contamination experiment was located behind each thruster (see fig. 2). In each contamination experiment there were two solar cell segments, each one of which consisted of a series string of ten 1x2 cm cells with fused silica cover glass. One of these segments, called the low temperature solar cell segment, was mounted directly on the extended surface radiator structure designed to simulate the 2 A.U. solar cell temperature (about -40° C). The sunside surface of this radiator was covered by an electrically grounded multilayer thermal insulation which had cutouts for the solar cell segments. The other segment, called the high temperature solar cell segment, was mounted to the same radiator plate using thermal isolation techniques which allowed that segment to operate at about 60° C (1 A.U. condition). There was a temperature sensor on each radiator plate (behind the low temperature solar cell segment) and on the back of each high temperature solar cell segment.

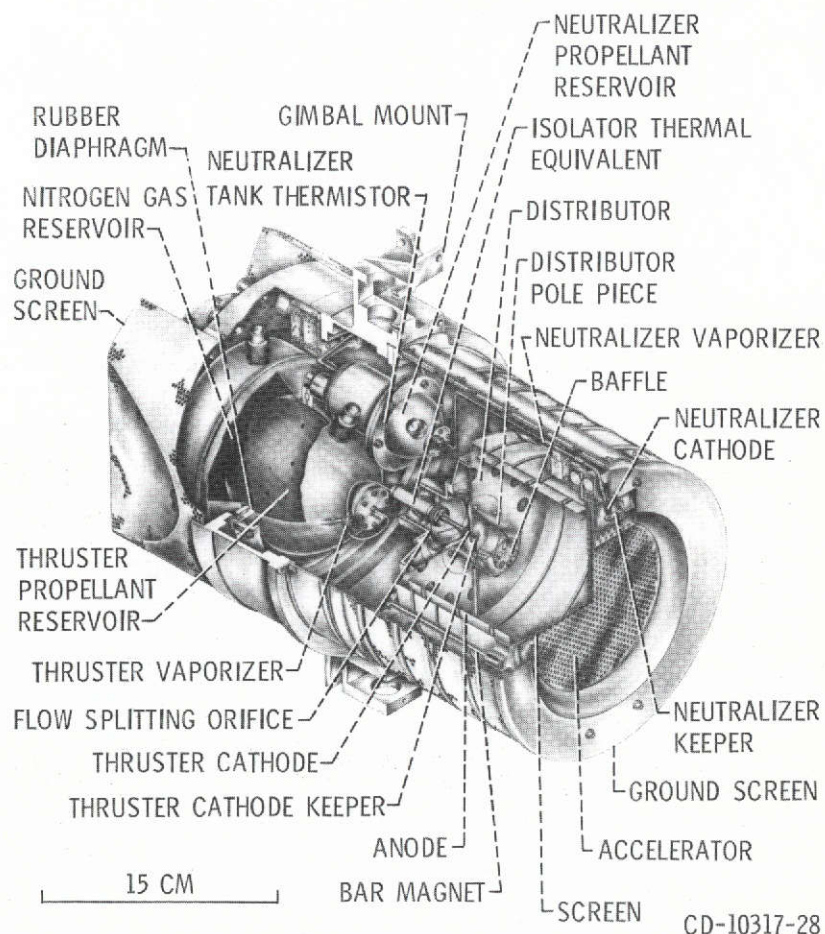
Figure 3. - SERT-II thruster.

Thruster. The thermal instrumentation on the ion thrusters was limited to the surfaces that were at electrical ground. This meant that the thermal performance of the thruster had to be determined from the neutralizer tank temperature. The location of this temperature sensor is shown in figure 3.

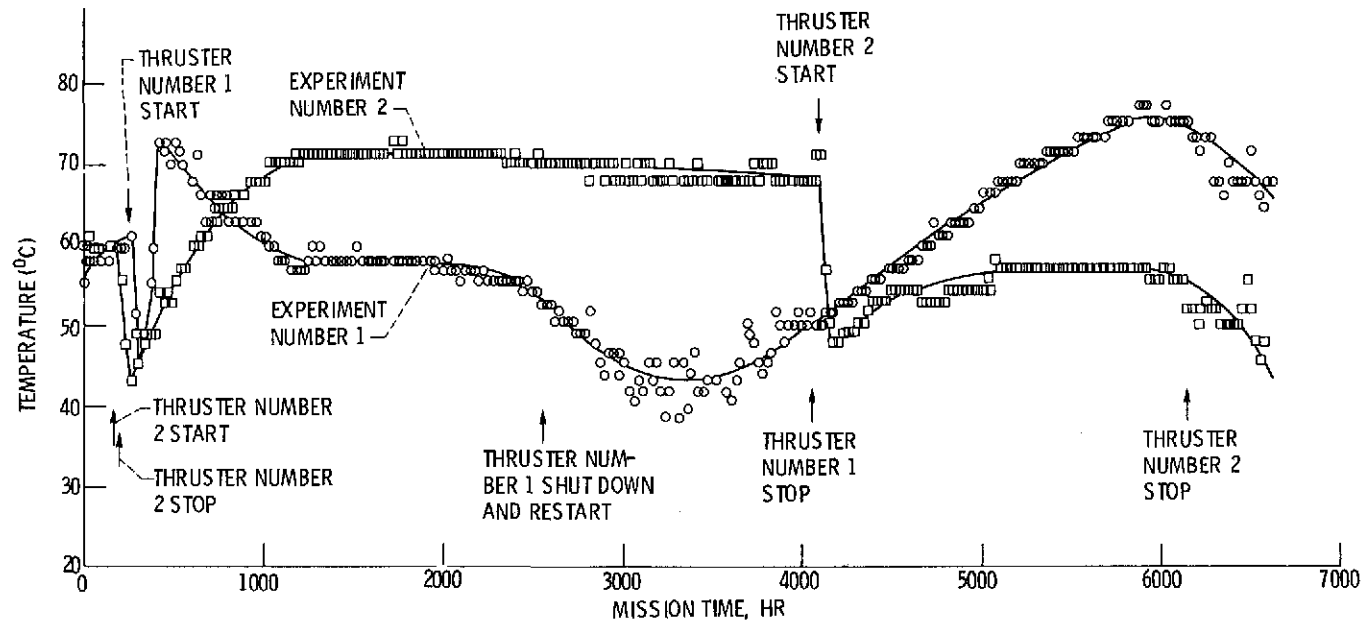
Figure 4. - Contamination experiment solar array temperatures - high temperature cells.

The flight temperature history of the high and low temperature solar cell segments (radiator plate) are shown in figures 4 and 5. The curves marked experiment #1 refer to the segments behind thruster #1 while the experiment #2 curves refer to the segments behind thruster #2. Since the temperature trends are more pronounced for the thermally isolated, low mass, high temperature segments, the discussion will be limited to this data. The same conclusions can be reached from the low temperature segment data.

It is obvious from the data (see fig. 4) that the segments are being coated by the ion thruster deposits. When each thruster was started, the segment temperature dropped indicating that the optical properties of the surface were changing. The electrical data for the segments⁽¹³⁾ showed that the glass transmission was decreasing such that the glass became opaque within 40 hours of thruster operation. This result verified the ground test data⁽⁶⁾ which indicated that any surface that had a view of the thruster accelerator would be coated by thruster efflux at a rate depending upon the view factor to the accelerator. The principal coating products obtained in this ground facility study were sputtered grid material particles which were being randomly distributed.

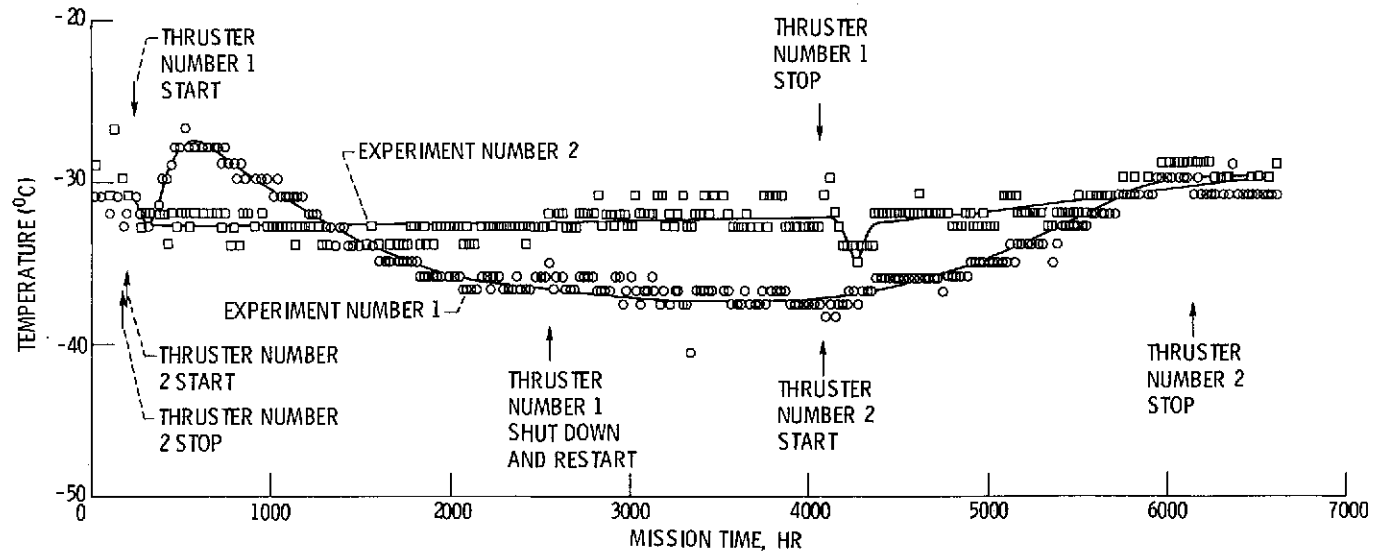
Figure 5. - Contamination experiment solar array temperatures - low temperature cells.

to be a strong function of the adjacent radiator plate temperature (see fig. 5). The heat balance equation assumes that the segment is in thermal equilibrium at each point in time. This is a reasonable assumption since each solar cell segment had a low thermal mass. Transient data obtained during flight eclipses verified this assumption. This equation lumps such additional heating terms as the absorbed albedo flux and the absorbed spacecraft reflected flux into the heat loss term.

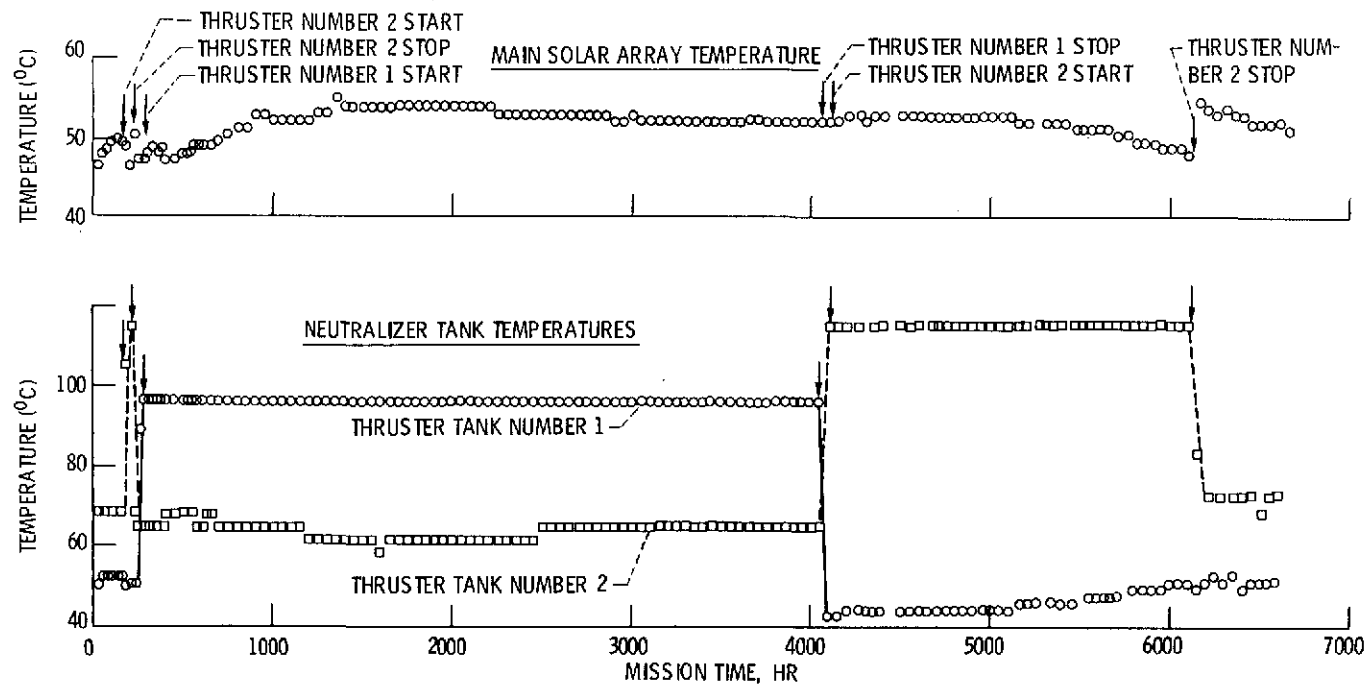
Figure 6. - SERT II temperature data.

The neutralizer tank temperature history is shown in figure 6. The thruster #1 neutralizer tank temperature reached equilibrium prior to the

thruster start. Then, the temperature rose to an equilibrium value, and remained at this value throughout the thruster #1 operational life. When the thruster shut down, the neutralizer tank temperature returned to its original value. The same trends were found with the #2 thruster neutralizer tank temperatures. Since the neutralizer tank temperature is a function of its optical properties, and since the tank temperatures returned to the same initial values that it had after the thruster operation, it can be concluded that there were no thermally significant coatings deposited on the neutralizer tank.

The temperature for the midpoint thermistor of one solar array wing is shown in figure 6. The other five flight thermistor readings agree with this data point varying slightly in magnitude due to temperature sensors. The temperatures indicate that there are no significant changes in the surface optical properties of either the covered solar cells or the paint on the rear surface of the solar array substrate. The variation in the temperature is due to the changes in the solar flux caused by the differences in the angle between the Sun and the array normal as the satellite orbited. The electrical characteristics of this array have been reported as being within the expected values for this mission.⁽²⁰⁾ Therefore, it can be concluded that no ion thruster exhaust particles have followed a curved trajectory such that they could deposit on the main solar array.

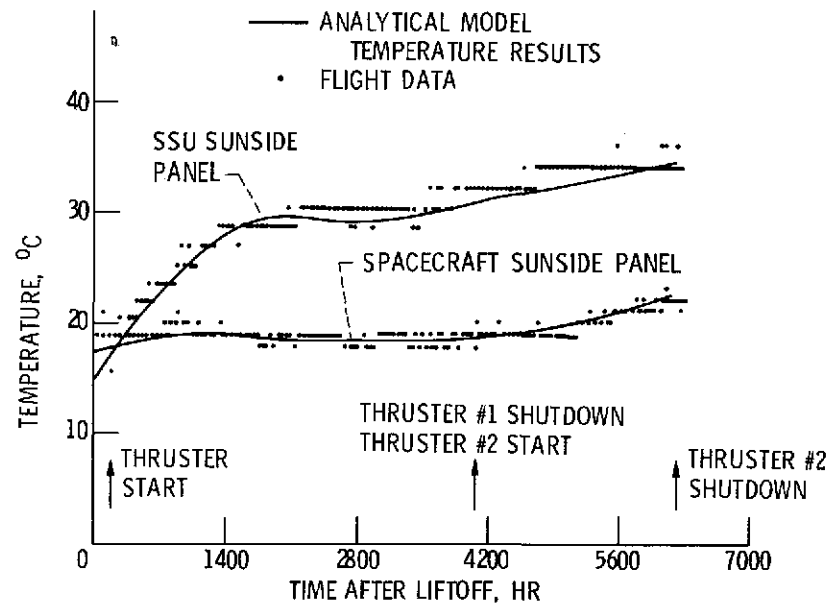
Figure 7. - Flight temperatures of the sunside panels.

The temperature history for these two sunside panels is shown in figure 7. A detailed computer thermal model of the SERT II satellite was developed and calibrated⁽¹⁴⁾ to be able to determine the change in the optical properties of the thermal control coatings. The analysis was accomplished and reported for the Z-93 white paint.⁽¹⁵⁾ The resulting changes in the solar absorptance for the paint on the sunside panels is shown in figure 9.

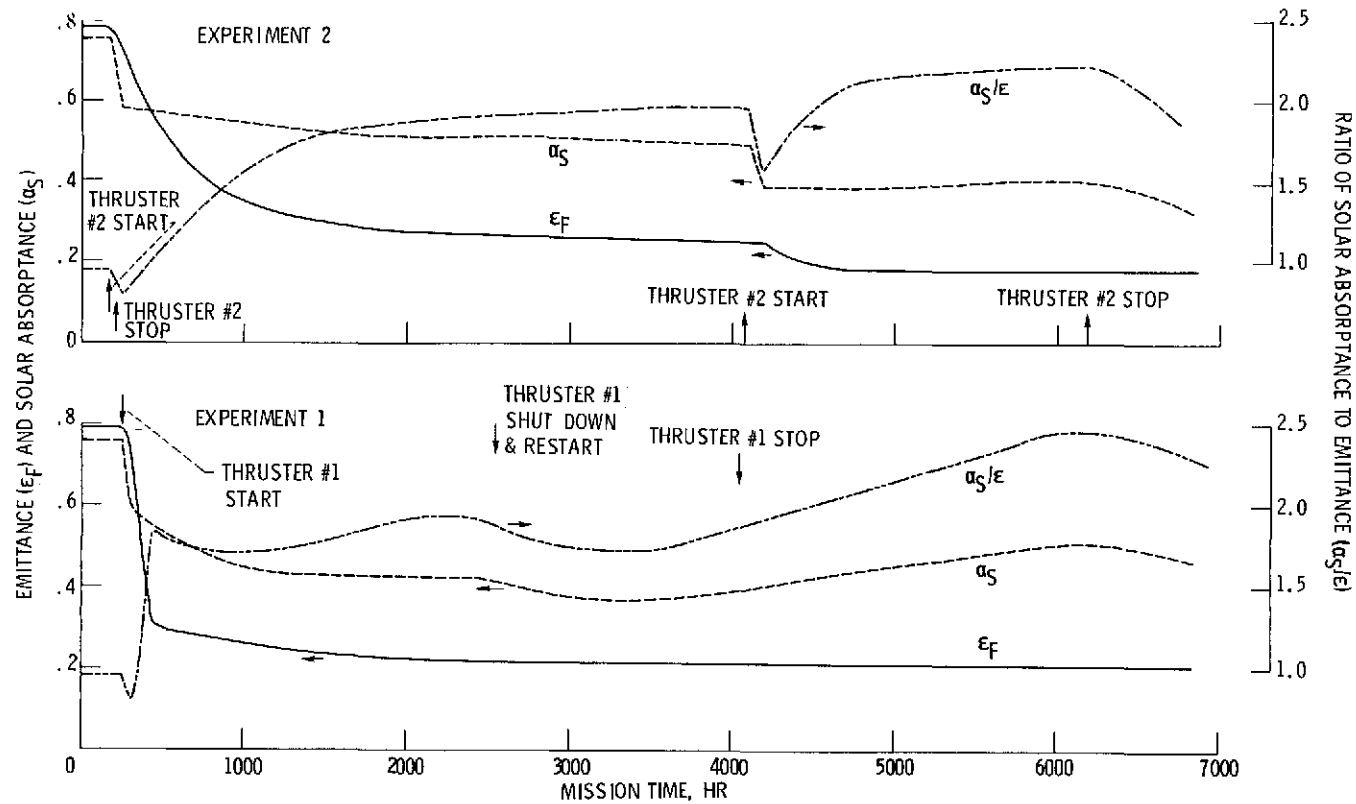
Figure 8. - Estimated optical properties of coatings deposited on high temperature solar cell contamination experiment SERT II.

After the thruster was turned on, the solution of the heat balance involved two unknowns: the solar absorptance (α_S) and the emittance (ϵ_F). The equation was solved for α_S over a range of values of ϵ_F at various times in the mission. Then, by assuming that both of these optical properties were smoothly varying parameters, it was possible to construct a set of curves for these values. The result of this analysis is shown in figure 8 and will be discussed in the following paragraphs.

The thruster start results in the deposition of a coating on the solar cell segment cover glass causing a change in both the solar absorptance and the emittance. However, the initial change in the solar absorptance is more rapid than the change in the emittance, which results in a decreasing temperature. This decrease in temperature corresponds to the decrease in the transmission of the cover glass in the first 40 hours of thruster operation. After this deposited coating becomes opaque, the process continues resulting in larger changes in the emittance and smaller changes in the solar absorptance. Hence, the segment temperatures rise. Finally, both properties tend to stabilize. The coating deposition rate occurs much more rapidly for the segment behind the operating thruster as expected.

When the thruster #1 shut down and the #2 thruster started, there appeared to be an acceleration in the deposition on the #2 segment. This changes the solar absorptance of the coating to approximately the value reached by the #1 segment more rapidly than the emittance change resulting in an initial temperature drop. Both optical properties of the coating stabilize in about 500 hours. The #1 segment temperature rise during this period is assumed to be due to an increase in the solar absorptance rather than a decrease in the emittance. There is insufficient data to verify this assumption.

For both segments the ratio of solar absorptance to emittance of the deposited coating reaches a value of 2.25 to 2.50 after the 5860 hours of thruster operation. This value corresponds approximately to that of a rough coating of molybdenum, the accelerator grid material. While the deduced values of α_S and ϵ resulting from this analysis are not absolute, a valid conclusion can be reached that the deposits from an operating ion thruster on glass will be of the rough surfaced, metallic type with an α_S/ϵ less than 3 and not a pure metallic coating with high values of α_S/ϵ . In addition, this flight data verifies the results obtained in vacuum tank testing.

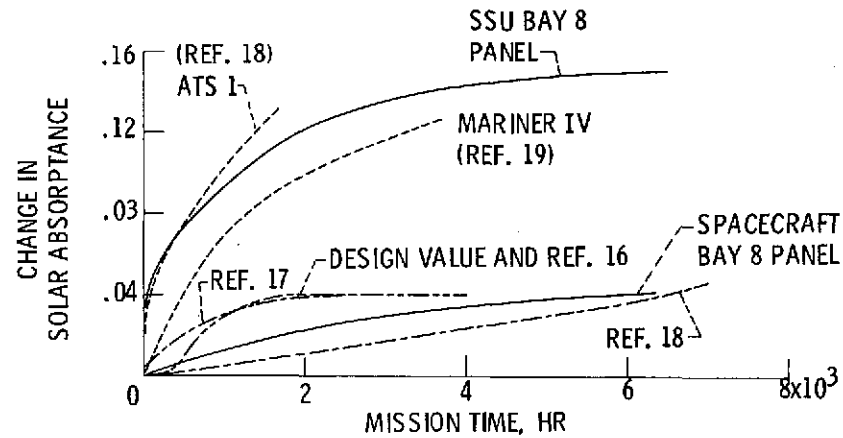
Figure 9. - Change in solar absorbance of SERT II Z-93 paint.

The change in the solar absorptance of the spacecraft sunside panel (bay 8) is well within the expected results based on laboratory ultraviolet degradation tests.⁽¹⁶⁻¹⁹⁾ The SSU sunside panel (bay 8) has a more pronounced change in the solar absorptance. This degradation is believed to be due to the proximity of the paint on this panel to the shroud mounting ring which was coated with lubricants to guarantee shroud separation. The degradation is not due to the ion thruster operation, since the change in solar absorptance started at the beginning of the mission well before the first thruster start. The other two panels of the SSU (bays 1 and 7) that were coated with a pattern of Z-93 paint and polished metal had the polished metal portions next to the shroud mounting ring. The optical properties of the Z-93 paint of these panels followed the same trends as the spacecraft sunside panel.
